## Composite Sandwich Panels for Above Ground Storage Tank Construction and Repair.

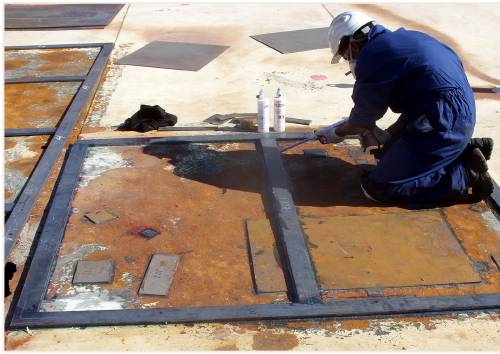
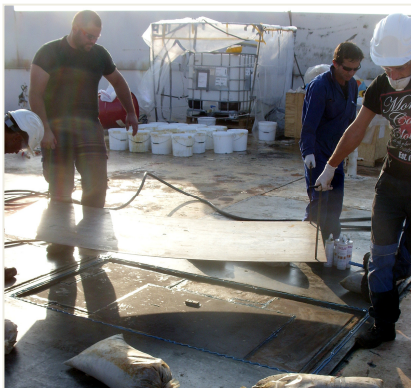
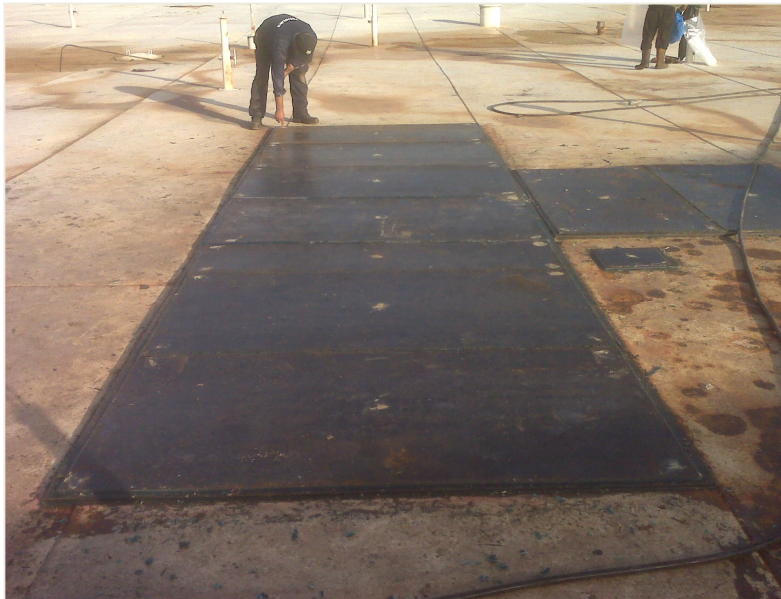
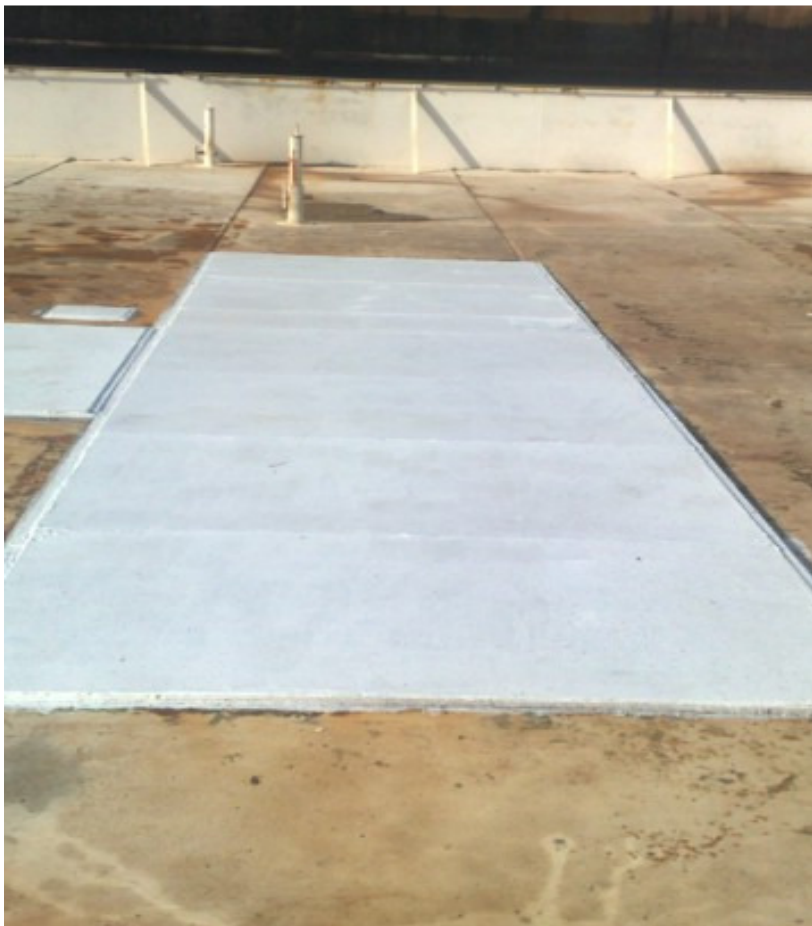
Recent projects have included the use of “No Hot Work “Sandwich panel repairs using offshore oil and gas industry standards to a floating roof in service. This resulted in prevention of water ingress to the floating roof, reducing the likelihood of it sinking or capsizing. The tank remained in service and avoided costly out of service costs. (pics 3/4/5/6/7)
